**CONDITION ASSESSMENT & LOAD EVALUATION
9TH STREET BRIDGE OVER SYDENHAM RIVER
CITY OF OWEN SOUND**

**APPENDIX "E"
PHOTOGRAPHS**

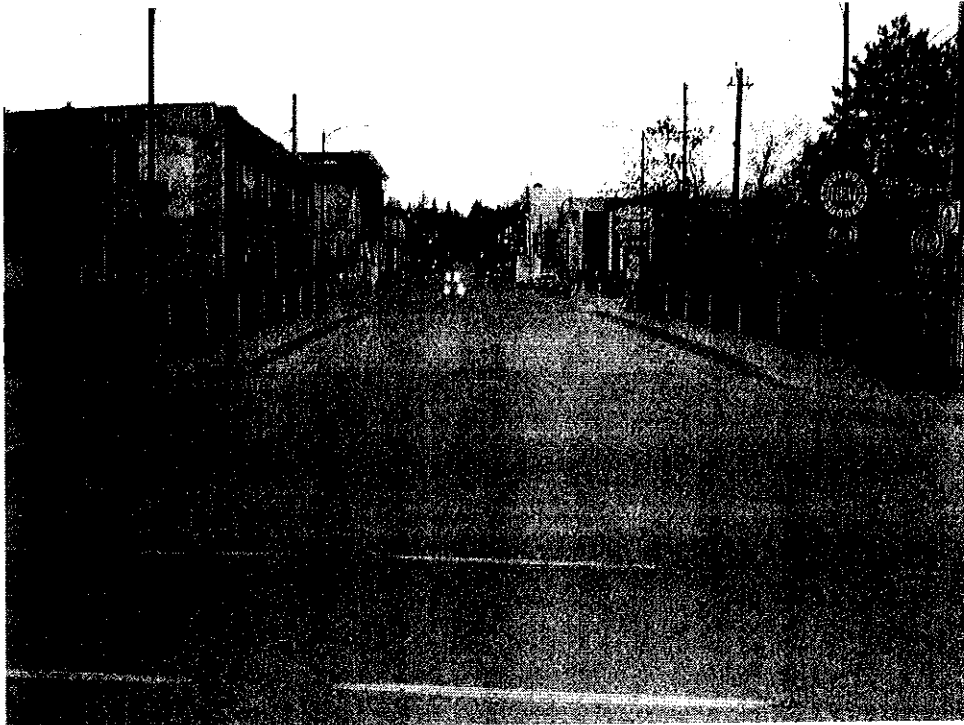
Photo 1 (IMG-1034)– View of the structure looking East.

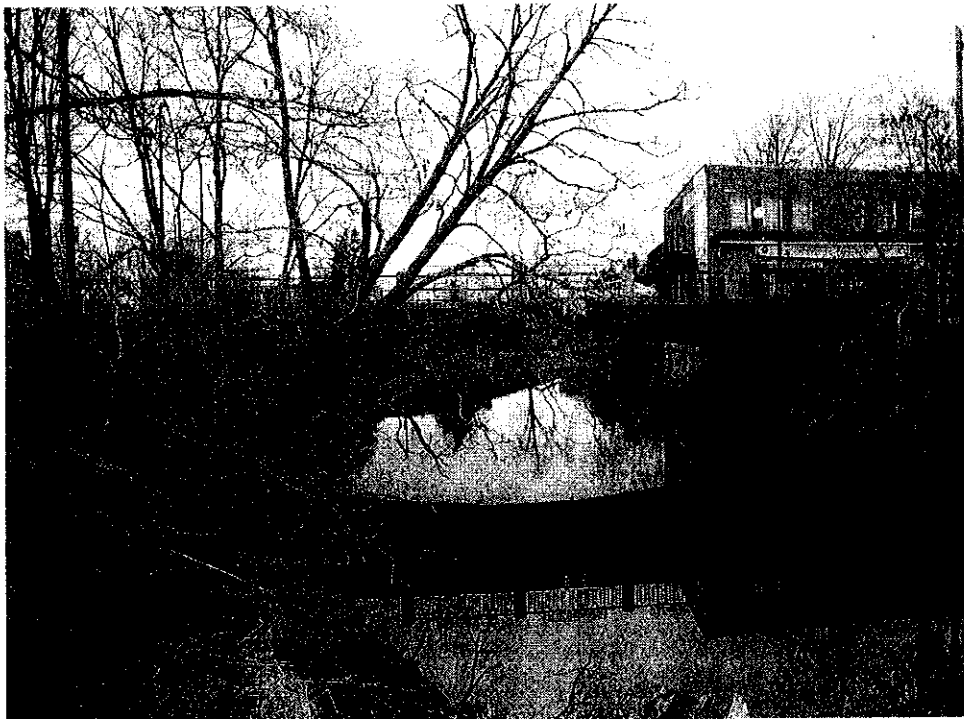
Photo 2 (IMG-1035) – View of the structure from the south west.

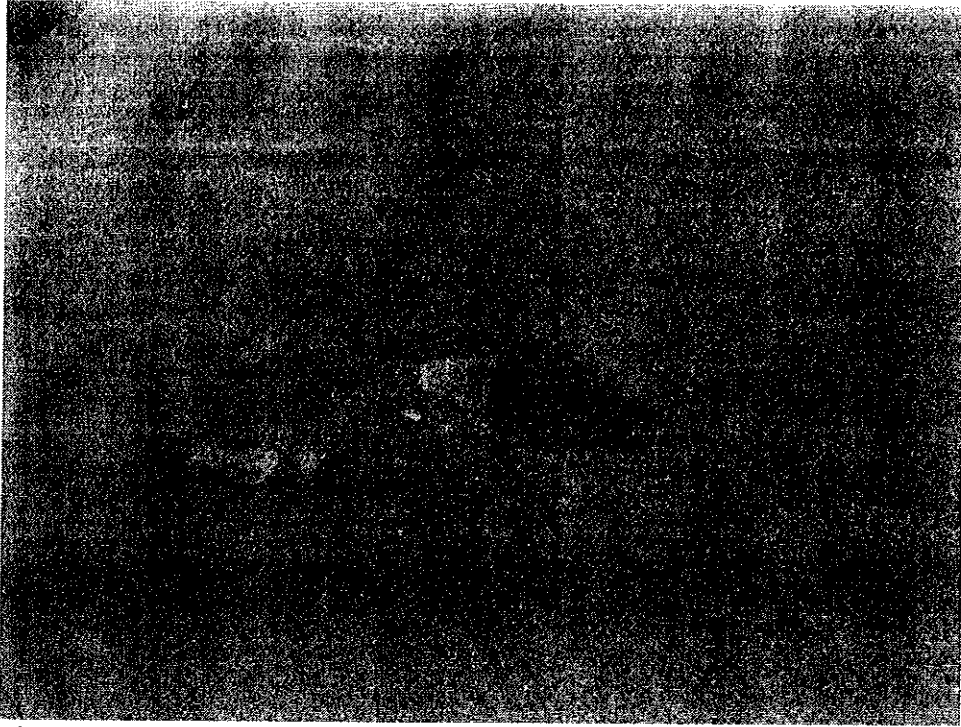
Photo 3 (IMG-1036) – Concrete wearing surface. Note the spalling. Patch work has been completed, however spalling is continuing.

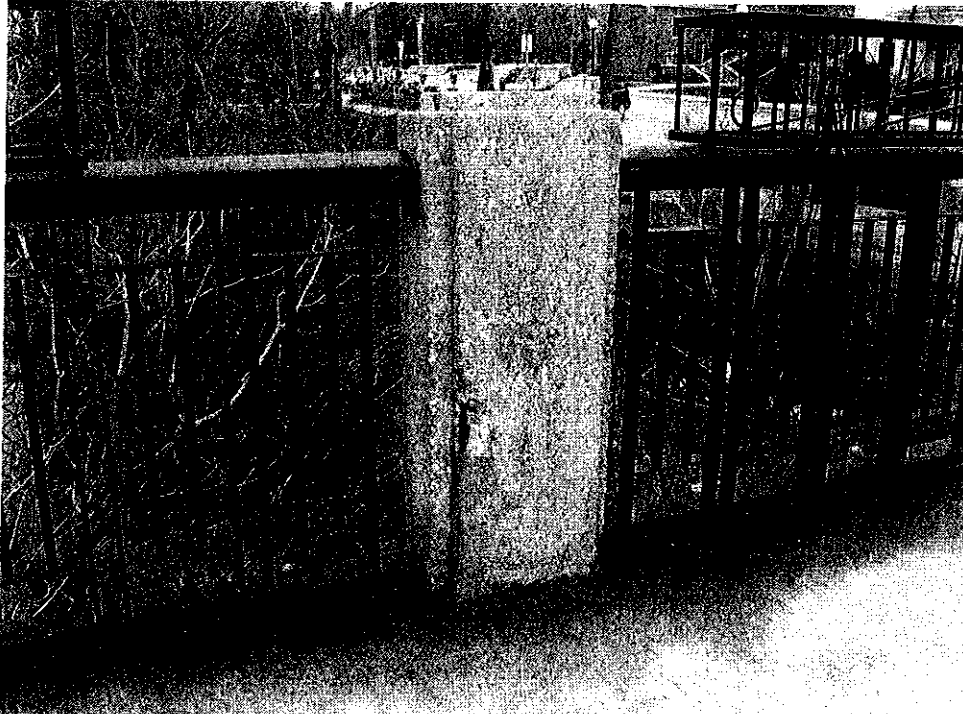
Photo 4 (IMG-1038) – View of the barrier post. Note the spalling exposing reinforcing steel.

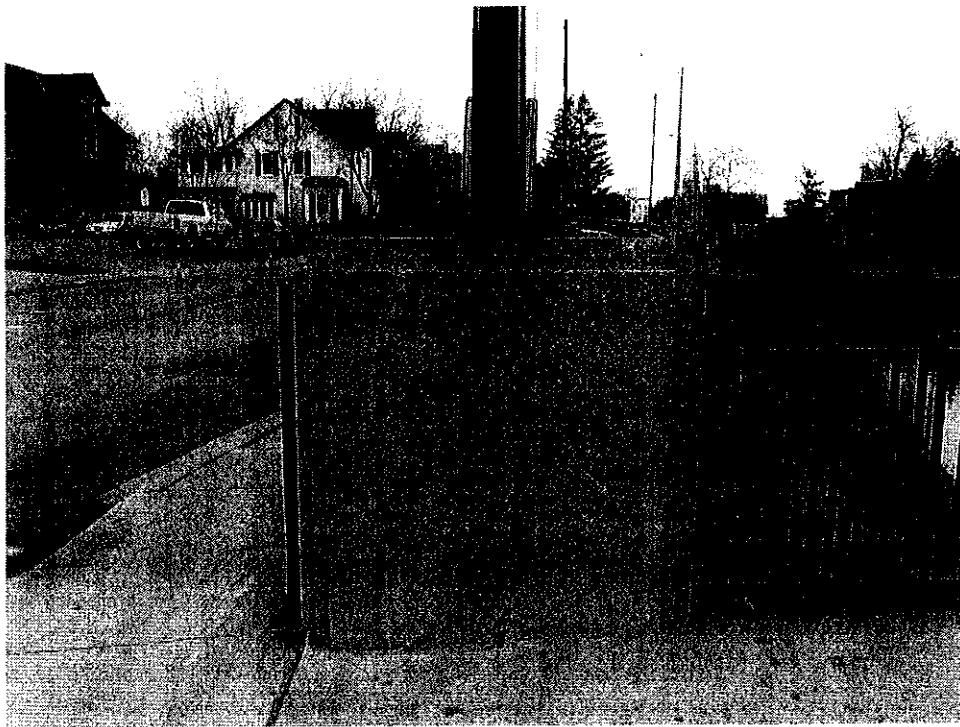
Photo 5 (IMG 1042) – Barrier post in north west corner. Note crack below lamp post and corrosion staining.

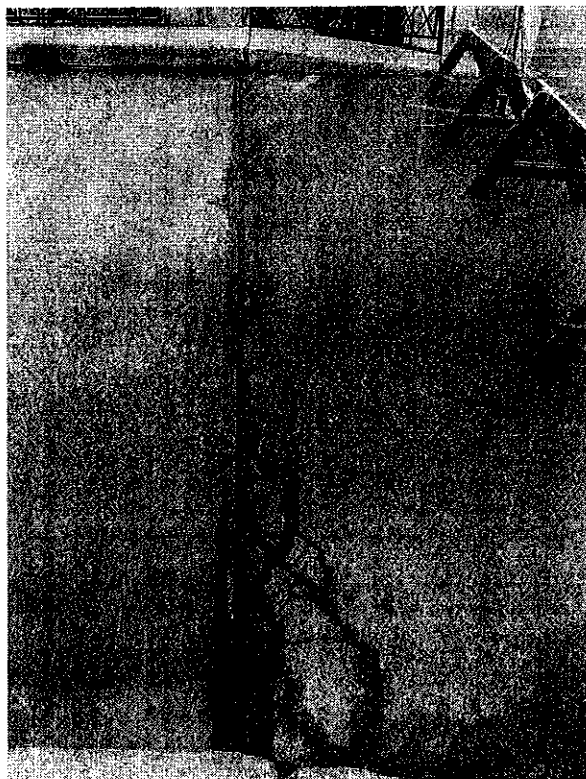
Photo 6 (IMG-1043) – View of west joist. Note break in armorage and cracking in west approach.

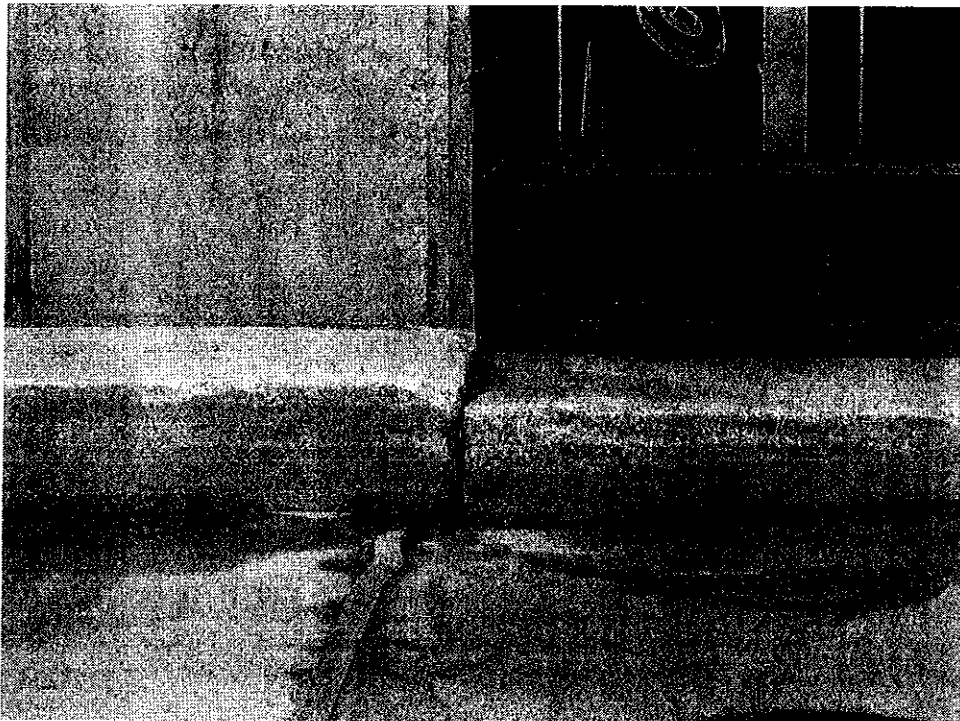
Photo 8 (IMG-1047) – View of north east approach sidewalk. Note settlement.

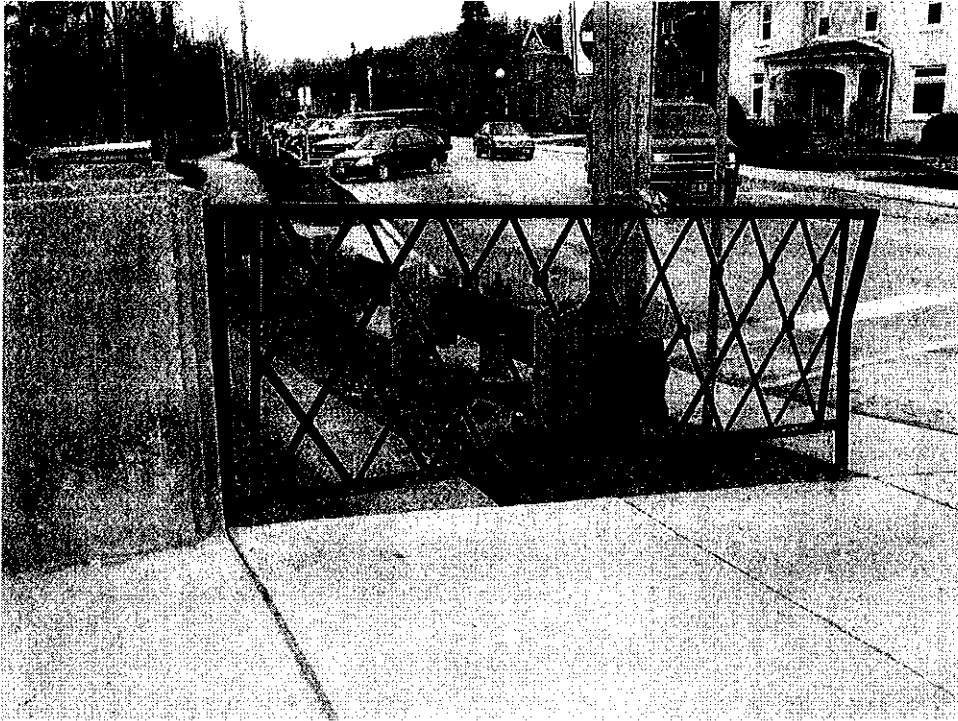
Photo 9 (IMG-1048) – South west approach guide rail is permanently deformed and sections are missing.

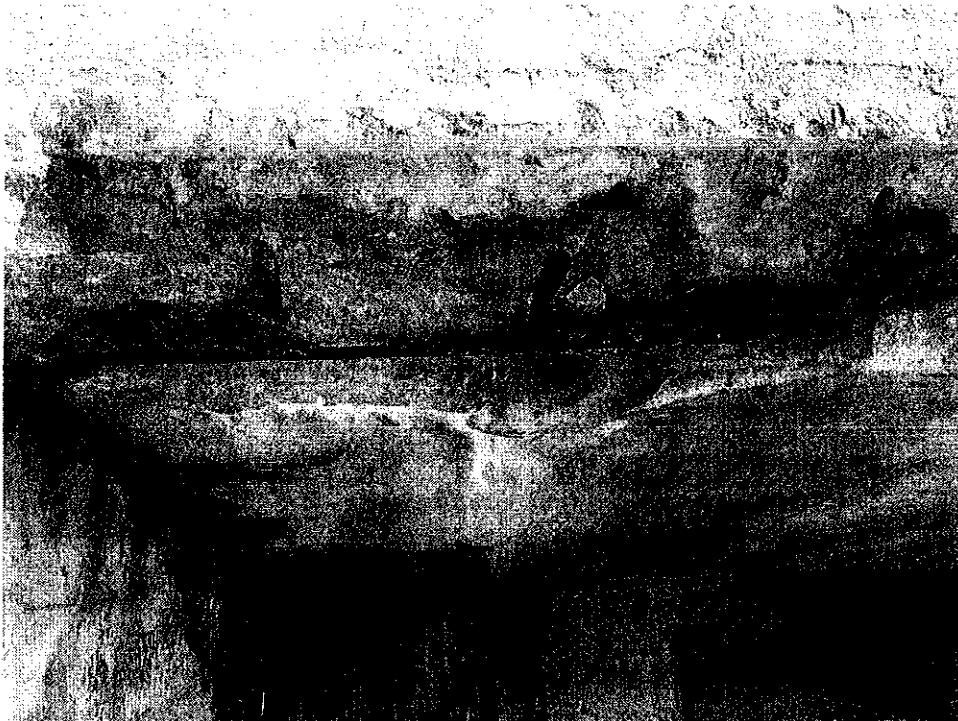
Photo 10 (IMG-1052) – Deck soffit in south west corner. Note spalling and delamination exposing reinforcing steel.

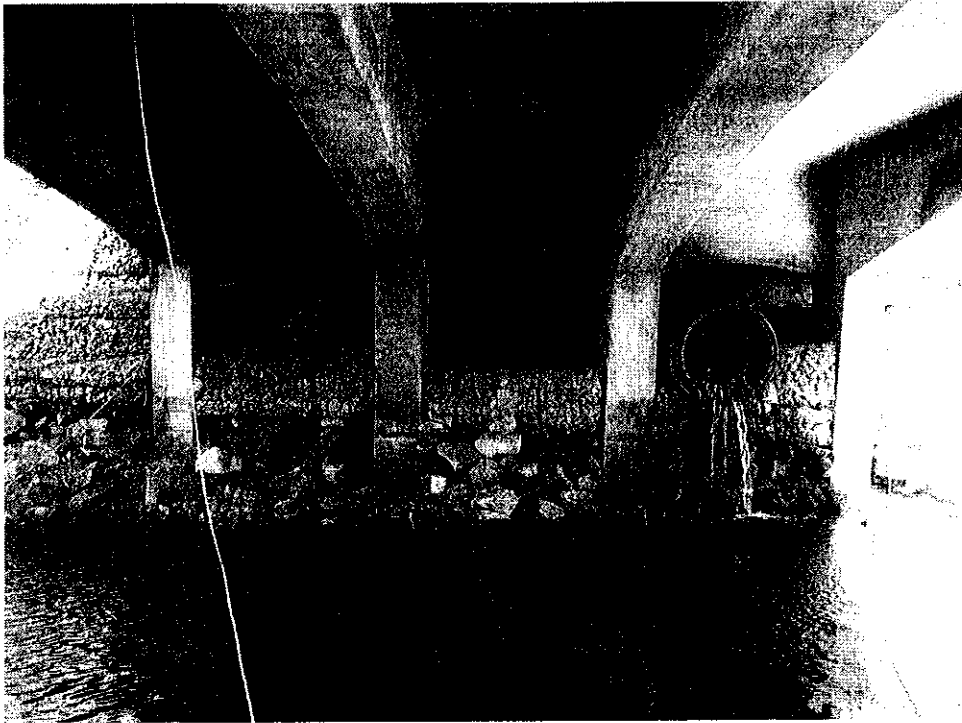
Photo 13 (IMG-1058) – View of intermediate piers on east side. Note vertical cracks in the two exterior piers.

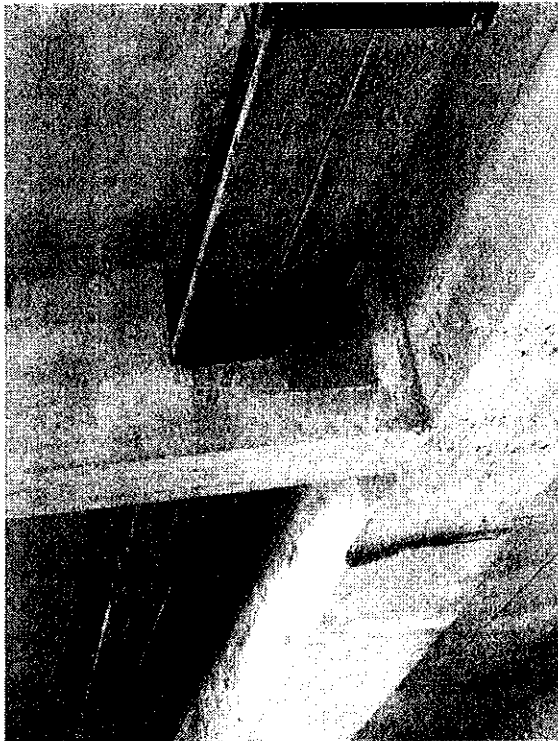
Photo 14 (IMG-1061) – Boxed out utility duct passing through centre purlin. Note the existing patchwork in the deck soffit and the vertical crack in the bottom north corner of the stringer.

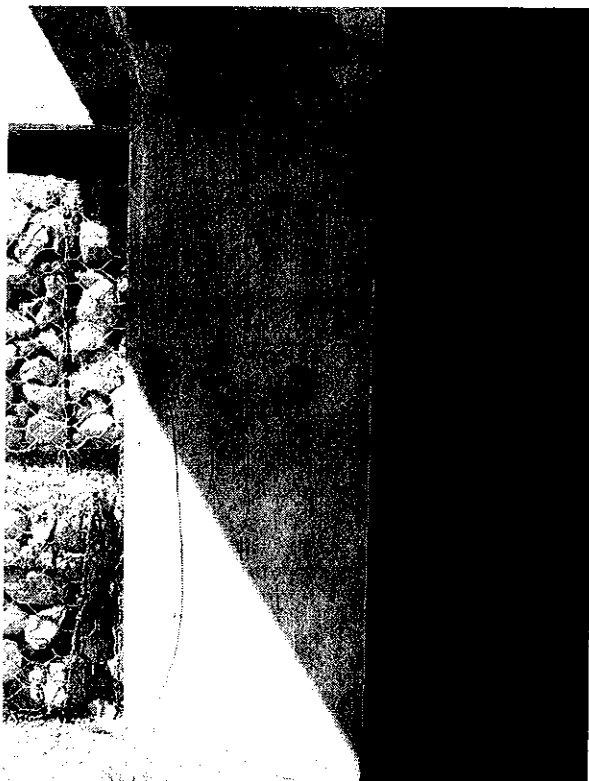
Photo 16 (IMG-1065) – North West intermediate pier. Note vertical cracks in patched area.

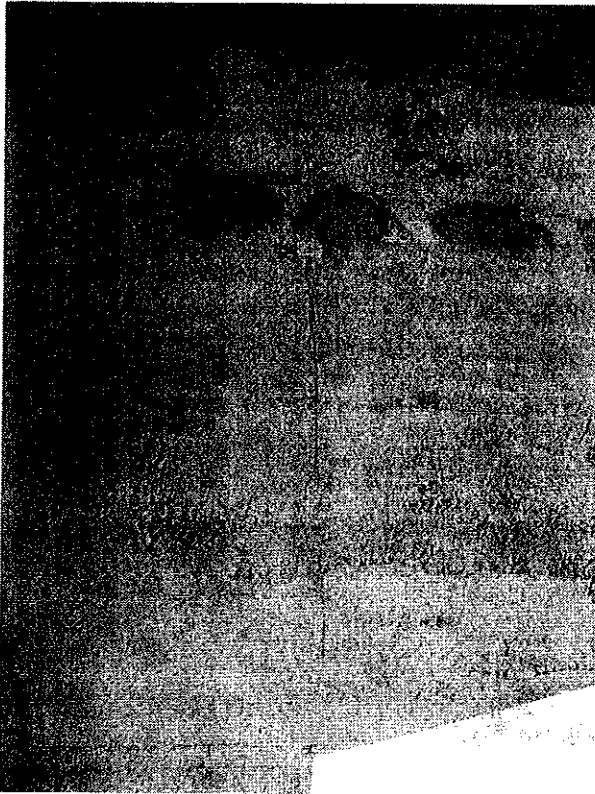
Photo 17 (IMG-1066) – Interior north east pier and girder. Note large vertical crack.

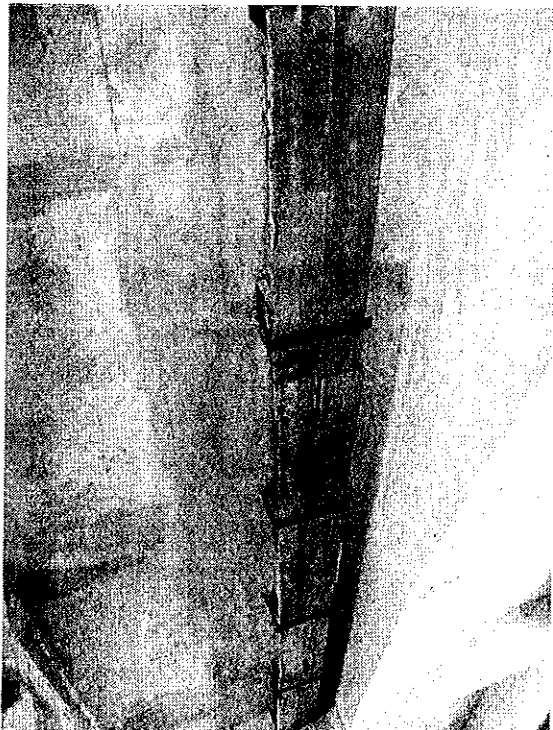
Photo 18 (IMG-1067) – Utility along underside of north span. Note extensive patching in area of duct.

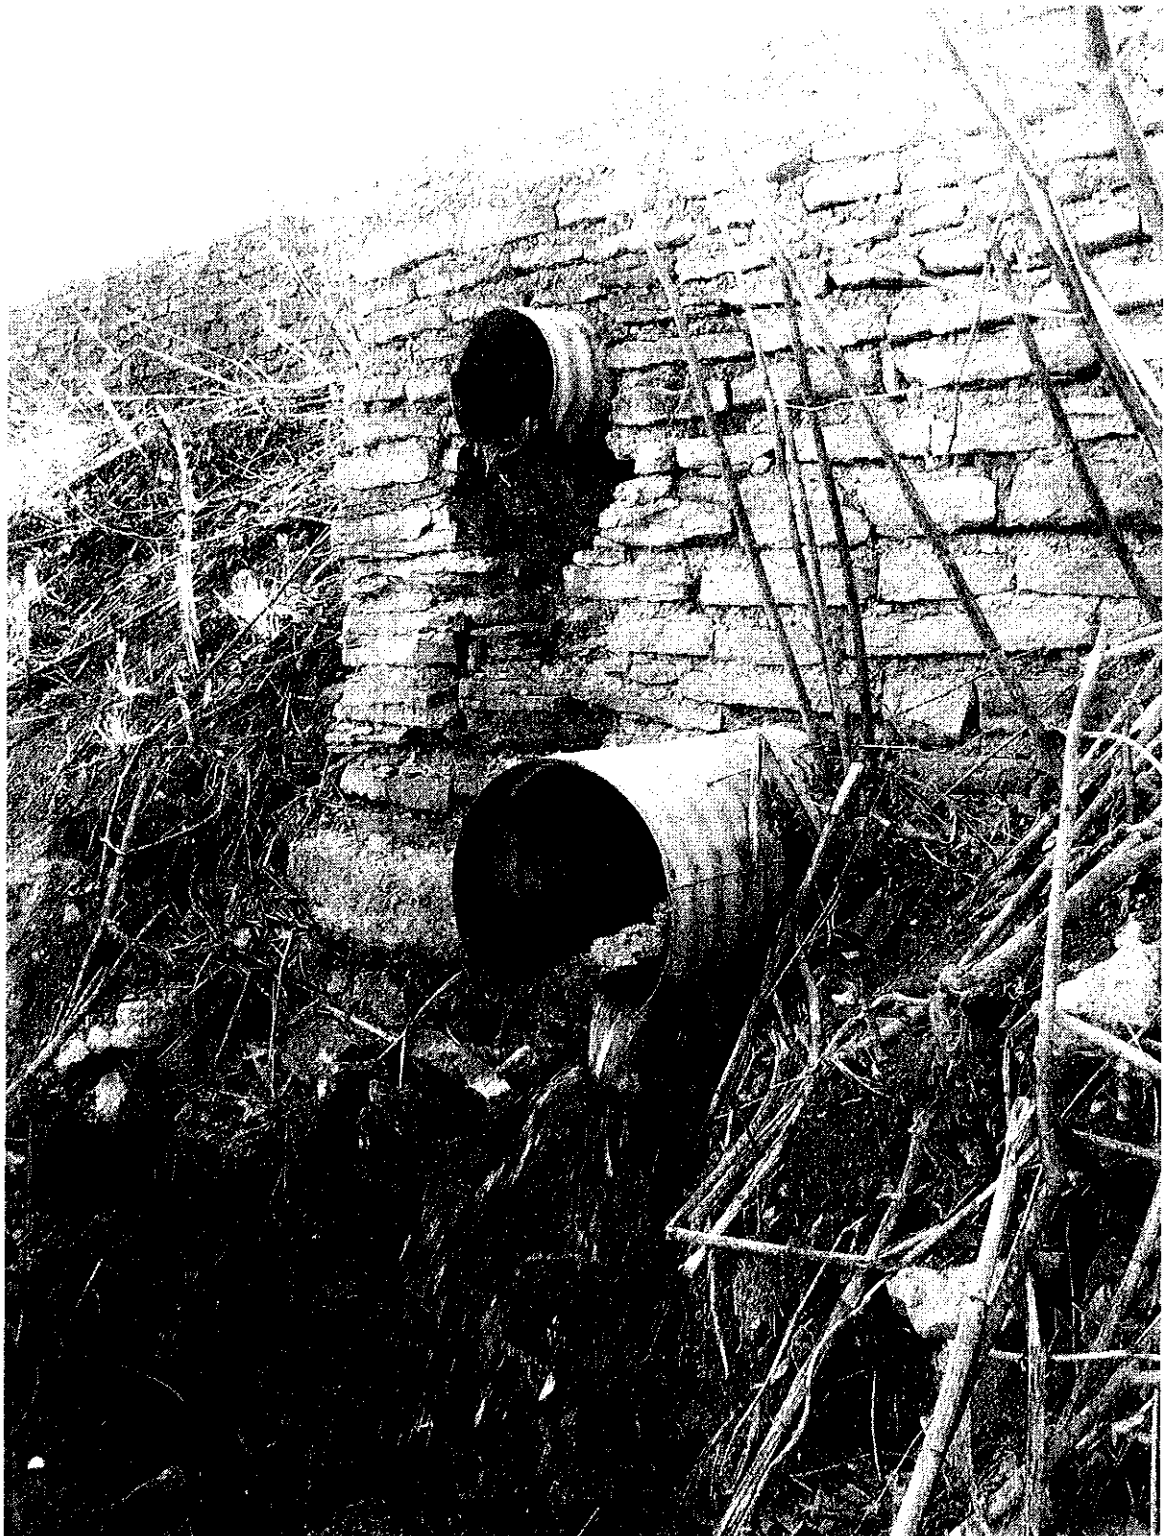
Photo 19 (IMG-4757) – Steel culverts in south west retaining wall. Note both bottoms are badly corroded. The water is causing very severe disintegration of the retaining wall.
